Progress M-27M Mission Updates

Flawed Separation System blamed for Loss of Progress M-27M Craft

Many open Questions remain in Progress M-27M Failure Investigation

Progress M-27M Failure Investigation focuses on Soyuz Rocket

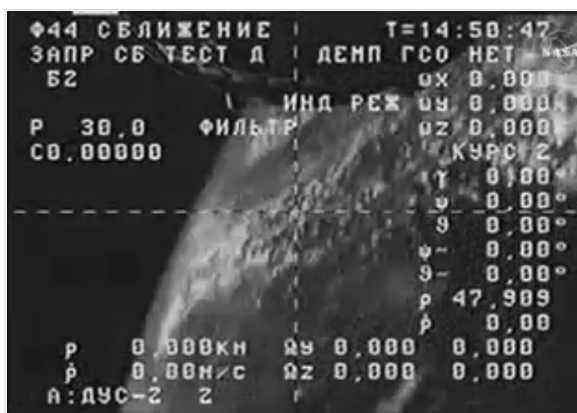
KURS Data Display

It quickly became clear that the telemetry feed from the spacecraft was only sporadic – only partial data arrived on the ground. Just enough data was collected to confirm that the two power-generating solar arrays had been deployed, but there was uncertainty on the KURS antennas and the propulsion system. A short blip of video was downlinked through VHF showing the KURS data screen that was to be used for a functional test of the system before

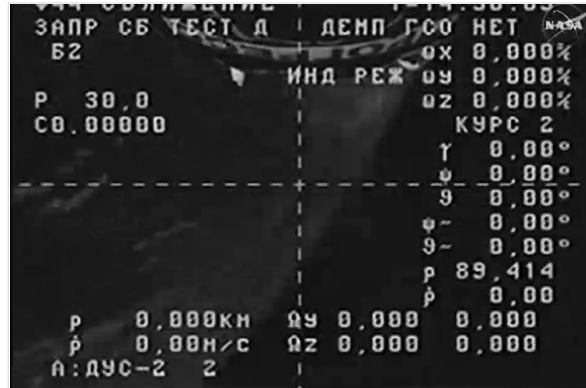
However, the fourth ground station pass delivered some video to the ground showing the Progress M-27M spacecraft in an uncontrolled tumbling motion at a significant rate of around 60 degrees per second along the long spacecraft axis which confirms that the vehicle has lost attitude control and can not use its propulsion system, further dimming the prospects of recovering the mission and regaining control over the spacecraft. The cause of the tumbling motion is unknown and could range from a botched separation from the launcher, to a leak in a propellant/gas line or tank or even point to a stuck thruster.
